## Category 1 – Basic Transportation

## Appendix A – Vibration Summary Report

To subject 5 off Vega 650 units to vibration testing to include a sweep test, resonance search and endurance at resonance.

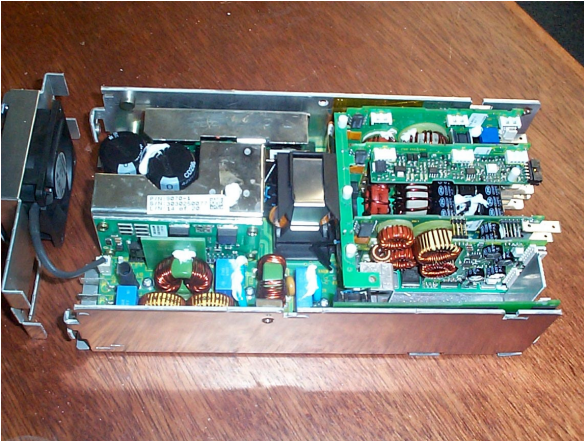
The unit tested was Vega 650 V603JBQ, pictured above, which contained the following issue pcbs and was fitted with C1, E1 (with option), H3/3 (with option) modules and a 100mA primary option.

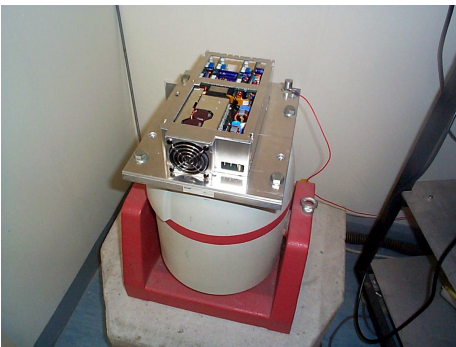
#### Plane 1 :

The unit was subjected to the following test with the unit mounted in each of the three planes as indicated below .

The unit was mounted onto a 3mm flat or right angle aluminium plate using the 4 off M4 customer fixings. The plate was in turn mounted to the vibration table. Mechanical inspection and Electrical testing was performed after the sweep test and after endurance testing. The following tests were performed :

The resonance search was performed with a stroboscope. The frequencies selected were worst case and the test was conducted on each of the three planes indicated in Fig. 1 .

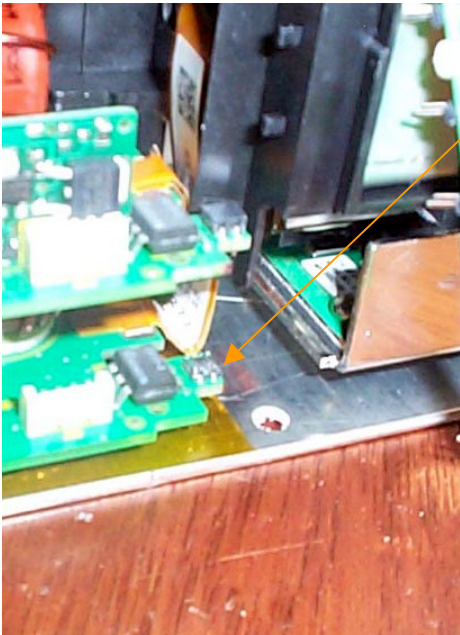
1). The plastic housing ovp connector on the C1 module had failed resulting in loss of connection to the ovp pcb. On investigation the E1 module had been assembled incorrectly resulting in the pcb not being square to the IMS which is mounted to the chassis (approx 2mm out of square). This resulted in an undue force being exerted on the C1 module ovp connector resulting in premature failure. The assembly problem was traced to a build up of solder in one of the flow solder

pallets which has since been removed. Instructions are in place for the cleaning of flow solder pallets and operators have been made aware.

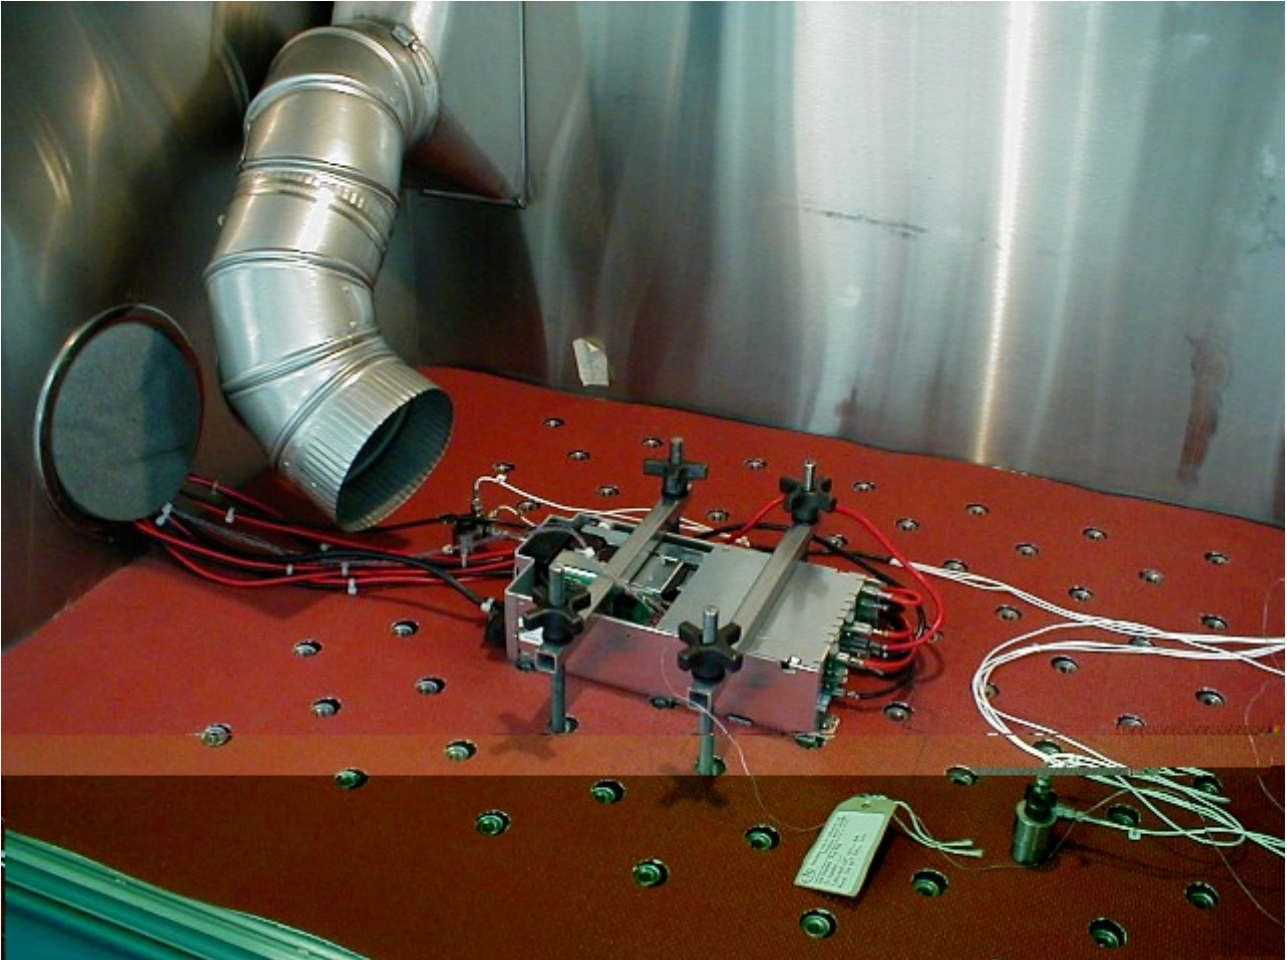
Test Sample No's 7 and 8. The combined test is the same thermal cycle as given in **Error! Reference source not found.** with the initial vibration limit at 5 G rms, this is then increased in 5 G rms steps for each subsequent thermal cycle.
